# ROBSON RASPBERRY IMPROVEMENT DISTRICT WATER SYSTEM ASSET STUDY MEMO

Robson Raspberry Improvement District (RRID)

20250902 – DRAFT FOR REVIEW

20251021 – ISSUED FOR FINAL

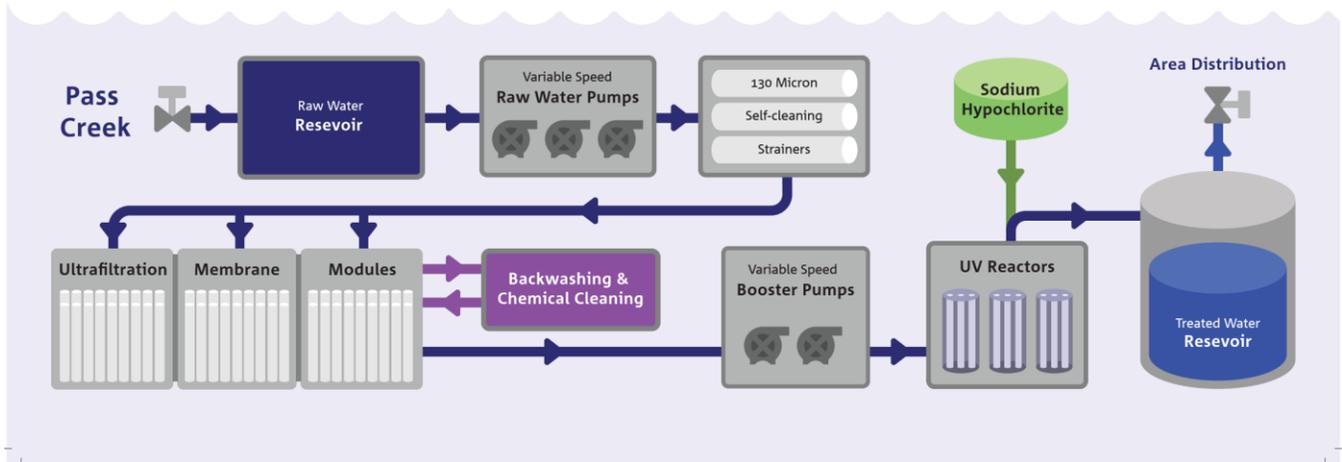
**FIGURE 1: RRID PROCESS FLOW DIAGRAM**

equipment, not the condition of other equipment. Note that electrical equipment is much more susceptible to damage and failure from a chemical spill than the treatment process equipment. **Figure 1** below shows the process flow diagram of the RRID water treatment plant.

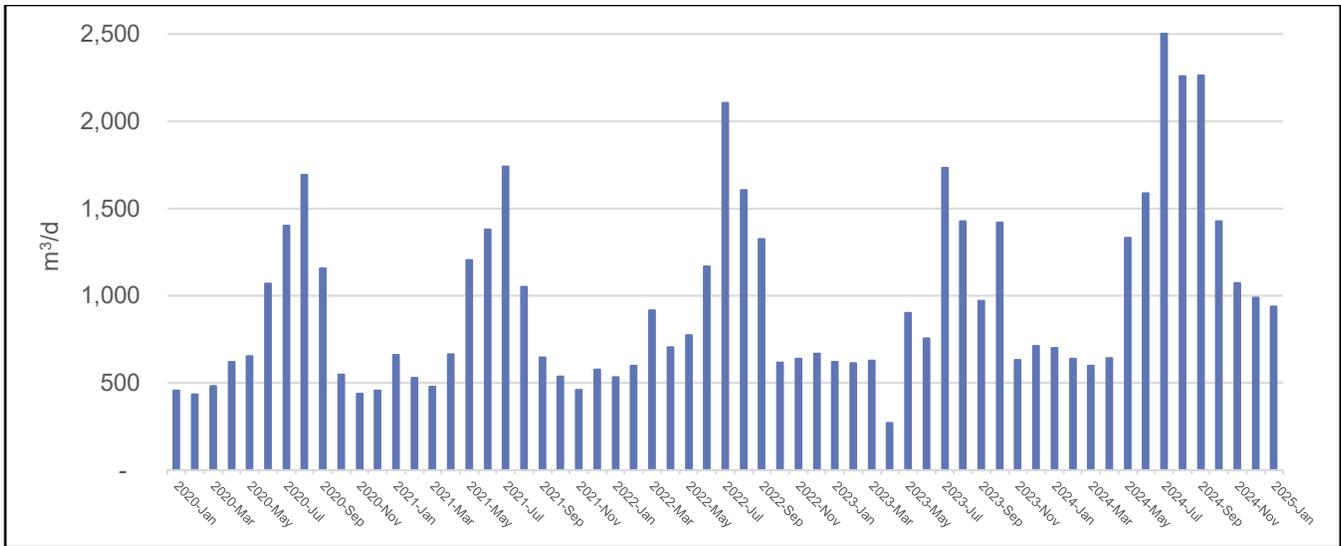
**FIGURE 2: RRID WTP AVERAGE DAILY DEMAND**

RRID has provided flow data from the WTP over the past five years. These are summarized in **Figure 2** below.

As shown in **Figure 2**, there is significant seasonal variation in the flows throughout the distribution system. As such, we evaluated seasonal flows across each year, with summer flows extending from April-September and winter flows extending from January-March and October-December.

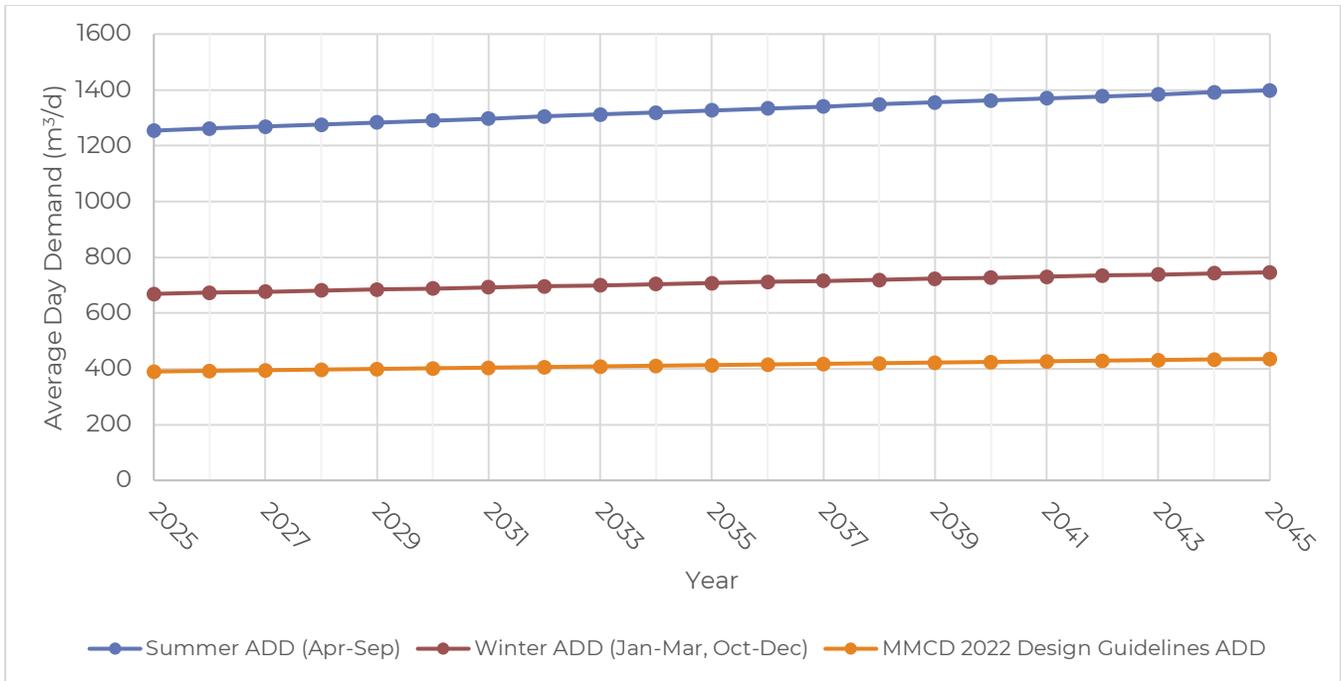
**FIGURE 3: ADD GROWTH PROJECTION BASED ON 3 NEW CONNECTIONS PER YEAR**

**Figure 3** below provides an estimate of ADD growth for summer and winter flow rates. We have also included an ADD growth projection based on the MMCD 2022 Design Guidelines, for comparative sake of a target for what's typical of a new system that's metered.
